ILLINOIS HOME INSPECTION

Client: Jonh Doe-SAMPLE

541 Maple-SAMPLE
Oceanside, CA 92054-

KEY TO THE INSPECTION REPORT

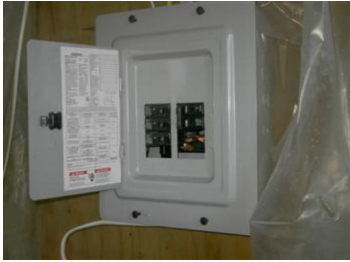
40-1. Main Panel
SAMPLE PICTURES

[] Power off at main - no inspection performed. (2)+ [X] Deterioration / Damage (2) [X] Near end of lifespan (2)
 [] Not functional (2)

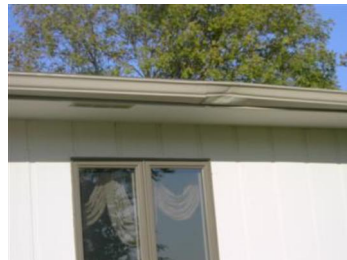
14-1. Gutters & Downspoi
SAMPLE PICTURES

Comments: Loose downspouts were noted at the time of the inspection. * Missing downspouts were noted at the time of the inspection.

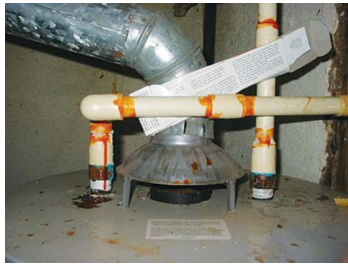
27-2. Water Heater(s)
SAMPLE PICTURES

Comments: The pipes and valves are corroded. (2) The water heater vent was back drafting. Products of combustion were spilling from the draft diverter. (2) (4) The water heater vent is damaged. (2) The water heater vent system is disconnected. (2) (4) The water heater vent has an improper rise. (2) Improper materials installed on vent system. (2) (4)

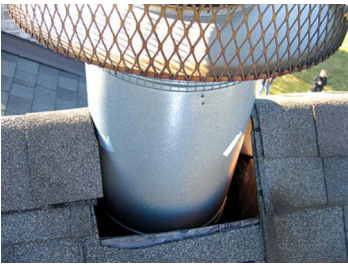
22-1. Exposed Flashings
SAMPLE PICTURES

Comments: Flashings were improperly installed at chimney. (2) Active leaking at: chimney. (2) The skylights are cracked at the time of the inspection. (2) The exposed flashings are broken at the time of the inspection. (2) Damaged flashings were noted at chimney. (2)
